COMPARISON OF FRACTURE RESISTANCE OF ENDODONTICALLY TREATED TEETH WITH FLARED ROOT CANAL, RESTORED WITH DIFFERENT NUMBER OF FIBER POSTS

อุษณีย์ บึงไพบุลย์^{1*} ภาวิณีย์ ปฏิพัทธ์วุฒิกุล ดิตรอน¹ นิสากอร์ เวศย์วิริยะกุล²
Usanee Puengpalboon^{1}, Pavinee Padipatvuthikul Didron¹, Nisakorn Vetviriyakul²*

¹ภาควิชาทันตกรรมทั่วไป คณะทันตแพทยศาสตร์ มหาวิทยาลัยศรีนครินทรวิโรฒ

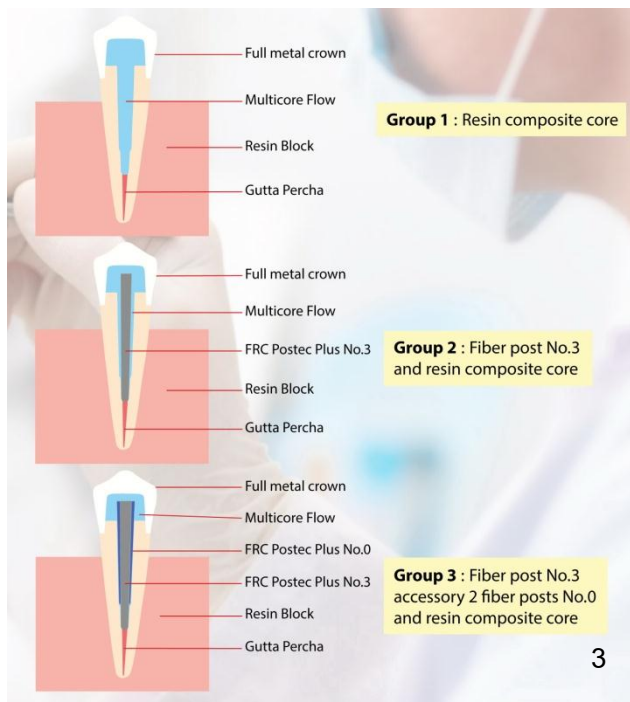
Figure 3: restorative protocols for 3 experimental groups

The specimens were randomly assigned into 3 experimental groups (n=5) which were restored with different protocols as shown in Table 1 and figure 3.

Group 1	Excite DSC, Multicore Flow
Group 2	Excite DSC, Monobond S, 1 glass fiber post (FRC Postec Plus no.3)
Group 3	Excite DSC, Monobond S, 1 glass fiber post (FRC Postec Plus no.3) and 2 glass fiber posts (FRC Postec Plus no.0)

The root dentin of each specimen was prepared with 37% phosphoric acid then an adhesive system (Excite DSC) was applied according to the manufacturer instruction. For group 1, Multicore flow was injected in the prepared post space to form the composite core. For group 2, the fiber post was applied with Monobond S, then a fiber post no.3 was tried in the canal, luted and fixed with Multicore flow. For group 3, a fiber post no.3 and 2 fiber posts no.0 were tried in

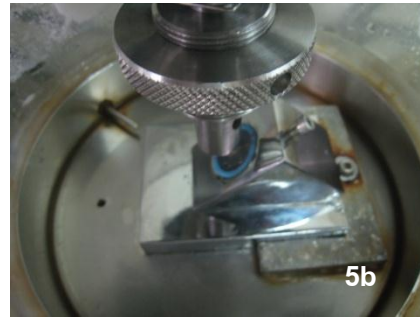
Figure 5a: The specimen restored with full metal crown mounting at 135 degree before testing in the Universal Testing Machine.

Figure 5b: The head of load cell was aligned 135 degree to longitudinal axis of the tooth.

All specimens were statically loaded with 10 kN load cell in the Universal Testing Machine (LLOYD, Model LR10K) using cross head speed of 1 mm/ minute at 135 degree to longitudinal axis of the tooth (figure 5a, 5b). The load was increased until the teeth were fractured and the force required to cause fracture was recorded. The data were analyzed by one-way ANOVA and Scheffe multiple comparison test. The fracture

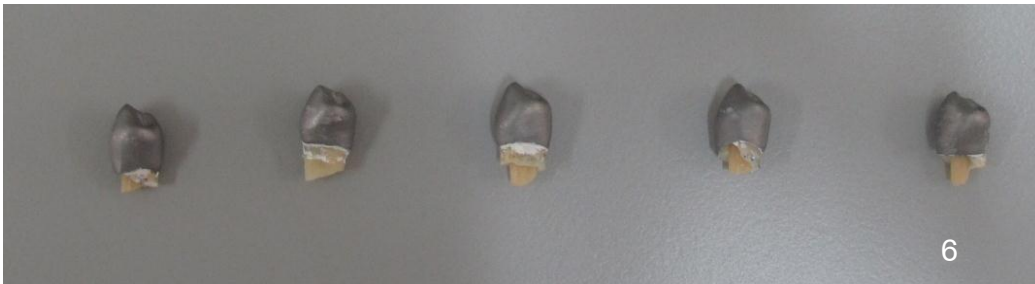
Figure 6: Fractured specimens from Group 1

Table 2 shows the results of maximum compressive load (N) of each experimental group. Group 1 has an average maximum compressive load of 361.8 N and most of the specimens fractured at the cervical third area, only one specimen fractured at the junction between middle and cervical third of the root. Group 2 has an average maximum compressive load of 559.46 N, all specimens fractured at the middle third area. All the fiber posts were not fractured in this group, only some crack and craze lines of the post were observed. Group 3 has an average maximum compressive load of 468.48 N, and 4 of the

Fracture site	Group 1	Group 2	Group 3
Cervical 1/3 of the root	4	-	-
Junction between cervical 1/3 and middle 1/3 of the root	1	-	-
Middle 1/3 of the root	-	5	4
Apical 1/3 of the root	-	-	1

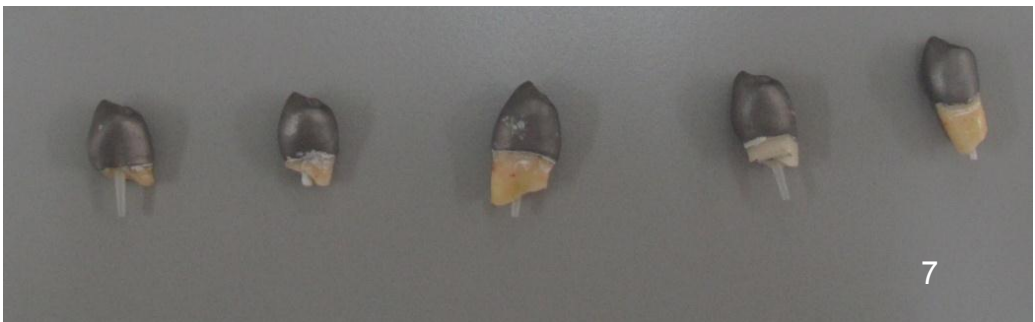
Figure 7: Fractured specimens from Group 2

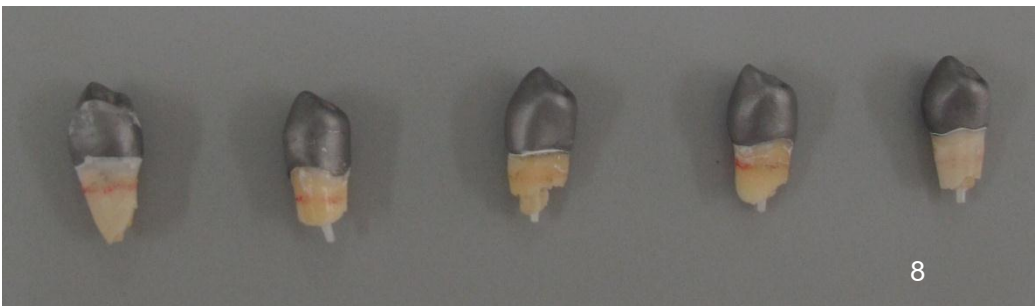
Figure 8: Fractured specimens from Group 3

specimens fractured at middle third, only one specimen fractured at apical third of the root. The fiber posts were not fractured except 1 post that was fractured at the apical third of the post.
